## Use Attainability Analysis

WBID 2519 Noblett Creek

Submitted by Missouri Department of Natural Resources Staff

## Data Sheet A - Water Body Identification

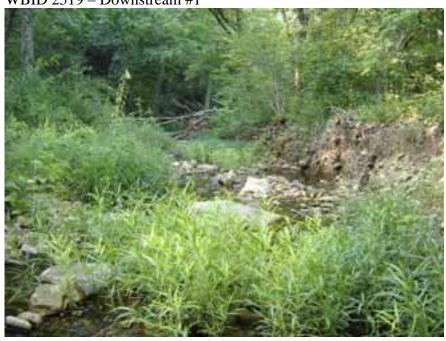
WBID 2519 – Downstream #1

Plow	Present	.?	Yes	No		Estir	nated	ft3/s	ec):				
Pool	Width (	(ft):	10'	Length	(ft): 40	' Avg.	Depth	(ft):	6*	Max.	Depth	(ft):	10*
Run	Width (	(ft):		Length	(ft):	Avg.	Depth	(ft):		Max.	Depth	(ft):	
Riffle	Width	(ft);		Length	(ft):	Avg.	Depth	(ft):		Max.	Depth	(ft):

25% Cobble 65% Gravel 10% Sand % Silt % Mud/Clay % Bedrock
--

Aquatic plants in streambed

Comments: Minnows and snails observed.

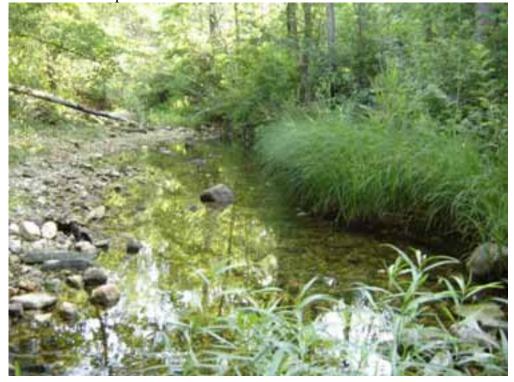
WBID 2519 – Upstream #1

Flow	Presen	t?	Yes	No		Esti	nated	(ft3/sec):			
Pool	Width	(ft):		Length	(ft):	Avg.	Depth	(ft):	Max.	Depth	(ft):
Run	Width	(ft):		Length	(ft):	Avg.	Depth	(ft):	Max.	Depth	(ft):
Riffle	Width	(ft): 8	11	Length	(ft): 108'	Avg.	Depth	(ft): 1.5*	Max.	Depth	(ft): 6'

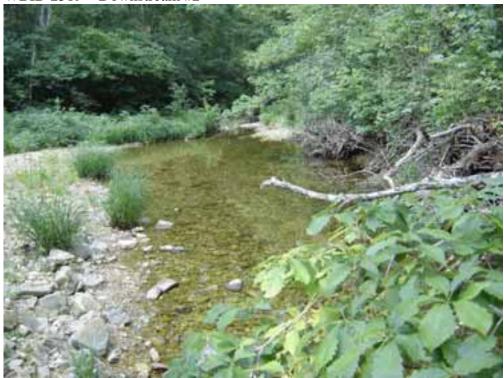
WBID 2519 – Downstream #2

Pool Width (ft): 16' Length (ft): 78' Avg. Depth (ft): 6" Max. Depth (ft): 10"	Run Pool	Width (ft	50000	Length (ft): 78'	Avg. Depth (ft): Avg. Depth (ft): 6"	Max. Depth	ATTENDALS
--	-------------	-----------	-------	------------------	---	------------	-----------

50% Cobble	50% Gravel	* Sand	% Silt	% Mud/Clay	* Bedrock
------------	------------	--------	--------	------------	-----------

1% algae, 40% aquatic plants in riffle

Comments: Minnows and crayfish observed.

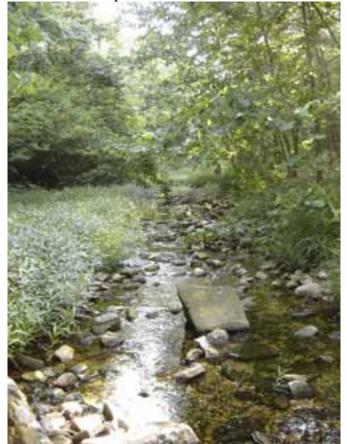
WBID 2519 – Upstream #2

Riffle	Width	(ft): 10'	Length	(ft): 50'	Avg.	Depth	(ft): 3"	Max.	Depth	(ft): 6*
Run	Width	(ft):	Length	(ft):	Avg.	Depth	(ft):	Max.	Depth	(ft):
Pool	Width	(ft):	Length	(ft):	Avg.	Depth	(ft):	Max.	Depth	(ft):
Flow	Preser	t? y	res No		Estin	nated	(ft3/sec):

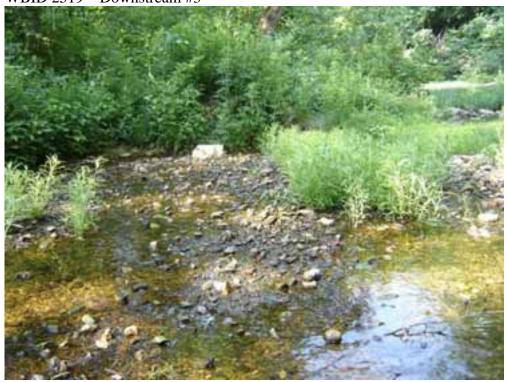
WBID 2519 – Downstream #3

Riffle	Width	(ft): 10'	Length	(ft): 33'	Avg.	Depth	(ft): 2"	Max.	Depth	(ft): 2*
Run	Width	(ft):	Length	(ft):	Avg.	Depth	(ft):	Max.	Depth	(ft):
Pool	Width	(ft):	Length	(ft):	Avg.	Depth	(ft):	Max.	Depth	(ft):
Flow	Presen	t? Yes	No	5	Esti	nated	(ft3/sec):

15% Cobble	75% Gravel	10% Sand	% Silt	% Mud/Clay	* Bedrock
 and a second of	1 2 2 3 3 3 3 3 3 3 3 3 3	200		a stand owner.	a production

<5% Algae

Comments: Minnows crayfish and Perch observed.

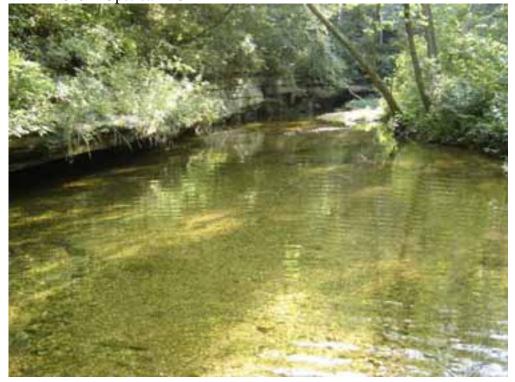
WBID 2519 – Upstream #3

Pool	Width	(ft): 16'	Length (ft): 122'	Avg. Depth (ft): 1'	Max. Depth (ft):
Run	Width	(ft):	Length (ft):	Avg. Depth (ft):	Max. Depth (ft):
Riffle	Width	(ft):	Length (ft):	Avg. Depth (ft):	Max. Depth (ft):
